Discovery and Elimination of Defects Causing Yield Loss on E-FET Power Amps

TriQuint Semiconductor, 2300 NE Brookwood Pkwy, Hillsboro, OR, 97124
trivers@tqs.com, 503-615-9297

Keywords: E-FET Leakage, Rinse Process, Photolithography

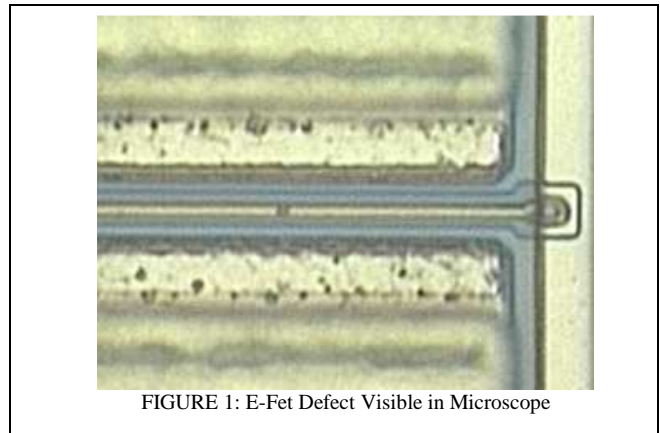
FIGURE 1: E-Fet Defect Visible in Microscope

Using IV curves, our Failure Analysis group was able to track down individual leaky devices. When they examined these through an optical microscope, they were able to find defects in the gate features (Fig. 1).

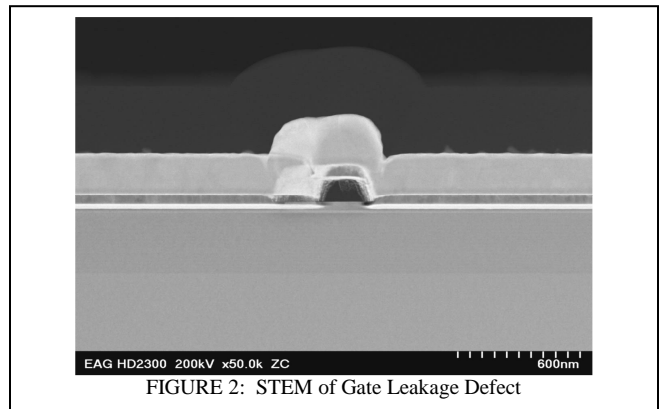
FIGURE 2: STEM of Gate Leakage Defect

They then obtained STEM images along the width of a gate and through one of the defects (Fig. 2).

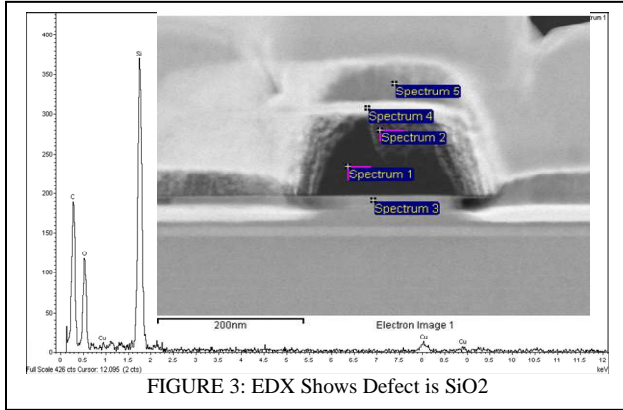
EDX was performed on the defect and the surrounding areas. The cause of the gate leakage was clearly found to be SiO_2 between the channel and the gate metal preventing the gate from shutting off in that area (Fig. 3).

As SiO₂ is the dielectric that we etch through to make gate contacts, we believe that a particle was blocking the etch. We believe this particle was then being removed by wet treatments in subsequent steps since, to date, the particle itself has never been found. It was always gone by the time analysis was done on the gate, and the only thing left behind was un-etched SiO₂.

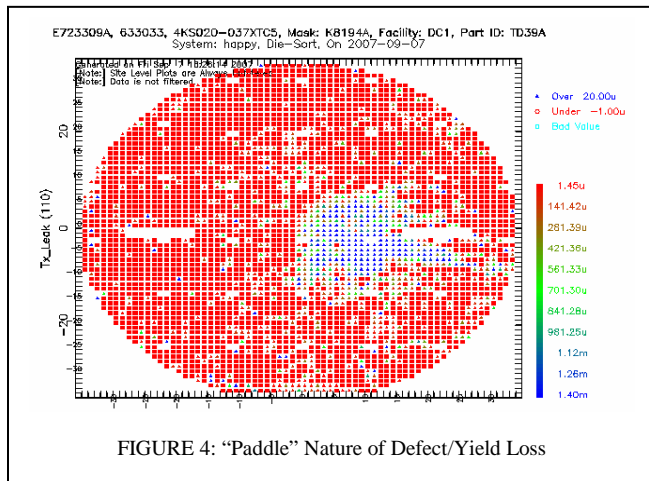
The first clue, obviously, was the remaining SiO₂. This told us to look at the steps prior to Gate Oxide etch. Another important clue was that the defects were often clustered together, near the center of the wafer, and they rotated around the center in a random pattern. Thus the failure was termed a “paddle” defect which led us to suspect that a specific tool with a paddle wafer loader was the cause (Fig. 4).

The rotation of the “paddle” signature also indicated that the wafers were not aligned in the same orientation when the defect occurred. In the end though, the most important clue was a simple first wafer effect. On all lots of this product, one wafer always yielded up to 15% better than the rest of the lot with no cluster of leaky sites, presumably, we
