Lessons Learned from Laser Dicing

Travis A Abshere, Moreen Minkoff, and Bill Howell

TriQuint Semiconductor, 2300 NE Brookwood Parkway, Hillsboro, OR 97124
tabshere@tqs.com, (503) 615-9445

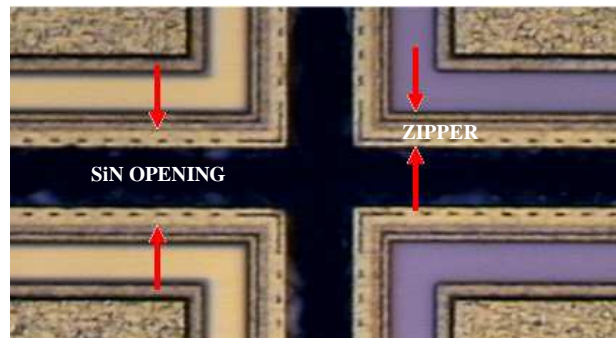
Figure 1. SiN Opening in Streets and on Part of Zippers

The majority of TriQuint product lines leave some dielectric layers intact in the streets. Metal zippers surround each die, protecting them from any chipping of the dielectrics that occurs during dicing. In the early exploration into laser dicing, it was determined that the scratch protection Silicon Nitride (SiN) coating placed on the top of the die could be an issue. When this coating was left in the streets, it was possible for laser induced dielectric damage to move beyond the zipper and into the die. This was compensated for by removing just that top dielectric layer from the streets with the opening extending from center of zipper to center of zipper (see Figure 1). The opening was

Initial testing of die with the new opening showed that it worked for preventing SiN chipping past the zippers. However, it uncovered an unanticipated issue at wire bond. One of our sub contract assemblers (SCA's) had a process that allowed the wires to sag when bonding chip to chip. The wire could sag to the point that it contacted the metal zipper and cause a short. While we had the scratch protect coating in place, it completely coated the metal, protecting it from wire sag. There was a two part resolution to this issue. First, the SCA fixed its wire bond sag problem (See Figure 2). Second, the opening in the SiN was reduced so that only SiN inside the street was removed, leaving the zippers completely covered plus 2um coverage into the street. Repeated testing showed that the reduced SiN opening provided the same level of protection from SiN chipping as the original opening that extended onto the zippers.

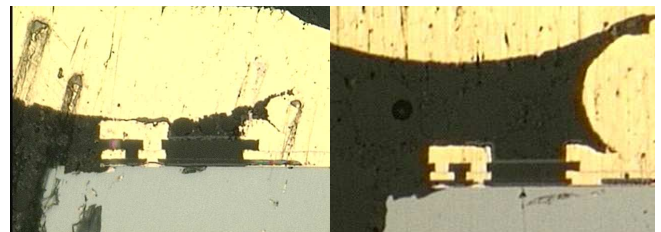
Figure 2. Cross Section of Bonded Wire Contacting Zipper (Left) and Sitting Above the Zipper (Right)

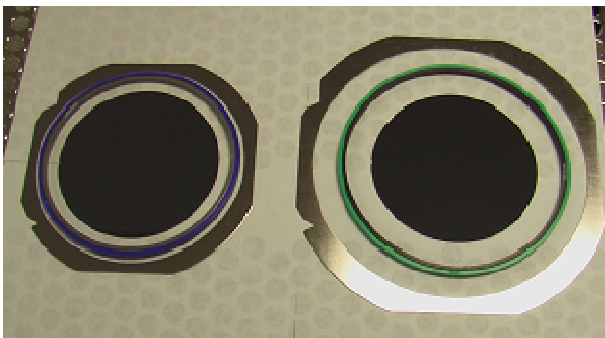
Figure 3. 6" wafers shown with original hoop and saw frame (Left) and current hoop and saw frame (Right)

It was a pleasant surprise to find that there were only minor issues with transferring diced wafers from the small saw frame to the small hoop ring. The recipe on the laser dicing tool required a minor adjustment to compensate for the small frame (due to tension of the tape from holding the frame down on the chuck) and the hoop stretching tool was more difficult to load with a small hoop, but it all worked – until the follow up batch of test wafers were sent to the SCA's to get picked.

The lesson learned from this experience is that complete samples need to be provided to the SCA's sooner. The drawings and sample rings were inadequate for discovering the die plate issues. Samples with wafers stretched on the hoop rings were sent as soon as a stretch tool (for putting the wafers on the hoop rings) was available on-site, but they could have been sent sooner if we had requested help from the vendor. It turned out that none of the SCA's had actually used small rings with 6" wafers. When the stretched wafers arrived, they all found that the small hoops prevented them from being able to pick all the way to the edge of each wafer. The end result was that we had to switch to a larger saw frame in order to accommodate a larger hoop ring,

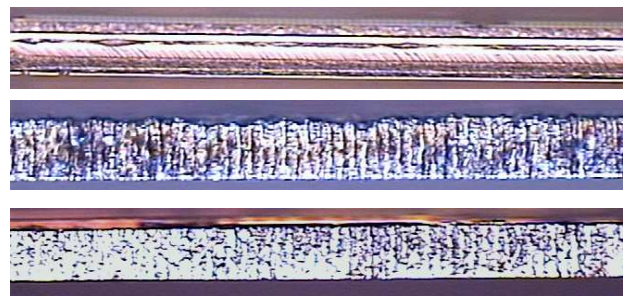
Figure 4. Die edge images typical for saw (top), laser diced with recast (center), laser diced after etch to remove recast (bottom)

Conversations with other ALSI customers who were laser dicing GaAs verified that they were performing a post laser-dice etch clean using similar chemistries as we had used in the past for a post-saw clean. The post-saw etch recipe was recreated and given minor adjustments in order to maximize cleanliness to the top of the die. Through the sharing of information from our industry colleagues and from ongoing work at ALSI, we learned that etch cleaning also made an improvement to die edge strength on laser diced GaAs die. Based on the similarity of the etch cleans and the end products (GaAs IC's), we moved forward with an etch clean in lieu of a top side protect coat clean.

Unfortunately, although the etch worked well to clean the top of the wafer, it did not completely remove recast on the sidewalls and did not provide a significant improvement to die strength for our die. This led to a die crack event that put a temporary stop to laser dicing until it could be resolved. The critical lesson here is that we may have avoided the die crack issue if we had reproduced the die strength testing with our own parts. We had viewed the etch clean more as an opportunity to avoid dealing with a protect coat process rather than a critical change for avoiding weak die edges.

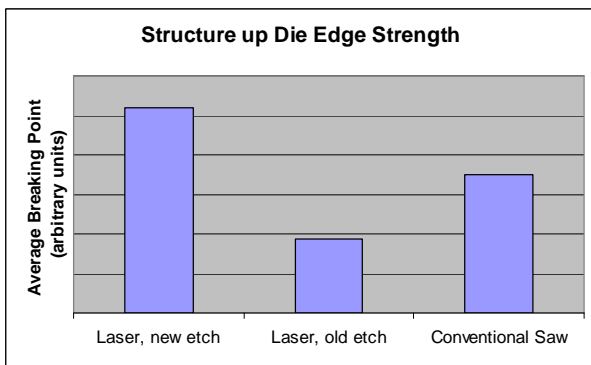
Figure 5. Impact of post laser dice etch on die edge strength

Die strength testing (performed for us by ALSI) showed that although the etch was cleaning the wafer surface, it was not providing an effective benefit to die edge strength. Some of the reduced effectiveness may be from dicing along a different crystallographic orientation than the die used by ALSI in the original experiment, but much of it was simply due to differences in the equipment and setup of the etch clean tools and that we were not stretching the wafers on hoop rings prior to the clean. A more automated tool was purchased and the etch clean chemistry was changed to provide both a clean top side and clean die edge. Stretching the wafers on hoop rings prior to the etch clean also improved the effectiveness of the clean by allowing more room for the solvent to get between the die. These adjustments resulted in a die edge strength superior to our conventional saw process (see Figure 5) and elimination of the die crack issue.
