Assessing Circuit Hermeticity By Electrolysis

William J. Roesch, Shawn Peterson, Amy Poe, Steve Brockett, Steve Mahon, and Jim Bruckner

TriQuint Semiconductor, Inc., 2300 N.E. Brookwood Parkway, Hillsboro, Oregon 97124-5300

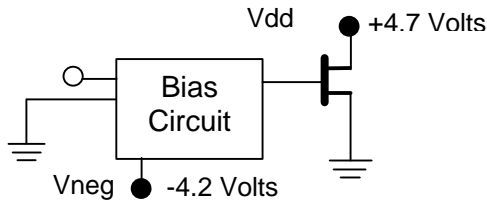
Figure 1. HVZPM Circuit Bias.

Bias. The bias selected for the HVZPM testing is historically unique. The test is conducted with 5 Volts across the FET channels and the gate pulled off hard to -4.7 Volts. The bias was intentionally selected by the customer to include high voltage (>8 Volts) and zero power dissipation (<<1mW). While this bias meets both the letter and spirit of the JEDEC 85°C/85% relative humidity specification (JESD22-A101), it does represent a new (and until now, un-reported) regime of humidity testing. Note: this is particularly applicable for RF power amplifier testing.

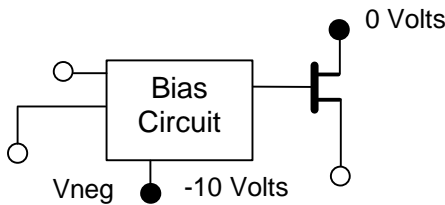
Figure 2. Typical Electrolysis Circuit Bias.

The electrolysis testing was performed on PCMs and circuits. PCM data was easy to interpret because of the separation of process layers in the various test structures. However, the circuit became the vehicle of choice because it is what fails in HVZPM testing. Eventually, three structure segments were observable and quantifiable as sources for the electrolysis bubbles: 1) LAB = Landed AirBridge, 2) FET = airbridge structures over interdigitated FETs, and 3) MET1 = Metal 1 (one) interconnects. For each wafer, three die sites were selected: A) near the edge (~1cm), B) mid-radial (~3cm), and C) near the center (~4.5cm). Each of the three die were probed, a drop of deionized water was applied, and then bias per Figure 2. The number of bubble sites were counted after the elapsed time of 1 minute, 5 minutes, 10 minutes, and 15 minutes.

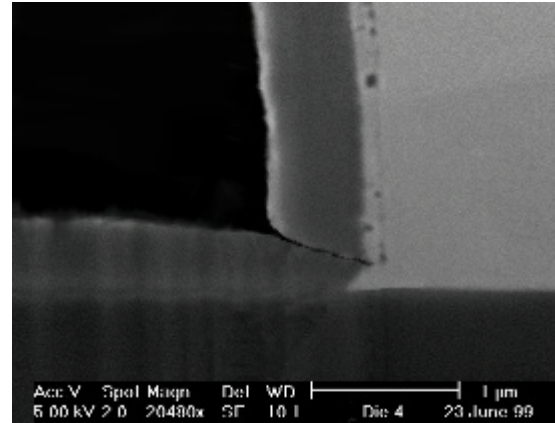
Photo 1. Typical Bubble Initiation Site.

The HVZPM test failure mode is increasing gate current. Operationally, this causes an unstable bias situation which can overstress the large FETs utilized in the design. The overstress will typically mask or destroy the failure initiation site(s). Two separate HVZPM failures have been analyzed precisely to the failing element. In both of these analyses, the failure site was determined to be in the larger interdigitated FET structures. Numerous analyses of electrolysis test sites have determined that the common moisture path into the circuitry is through a crack at the base of the landed top metal. Photos 1 and 2 are two electron micrographs (prepared by Focused Ion Beam cross-sections) of those cracks before and after bubble testing. These micrographs show the primary cracks and evidence of the electrolysis by-products moving through the cracks.

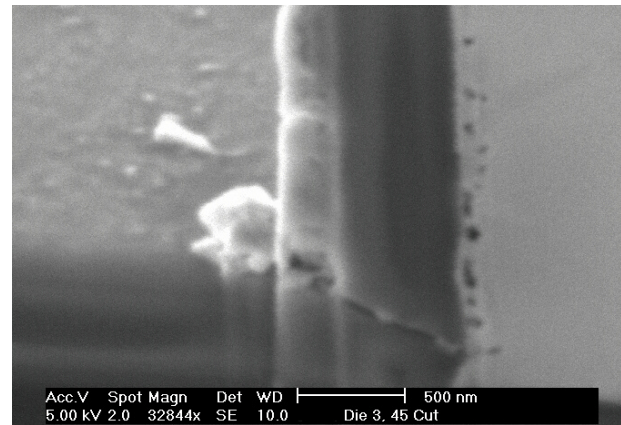
Photo 2. Typical Bubble Initiation Site With Debris.

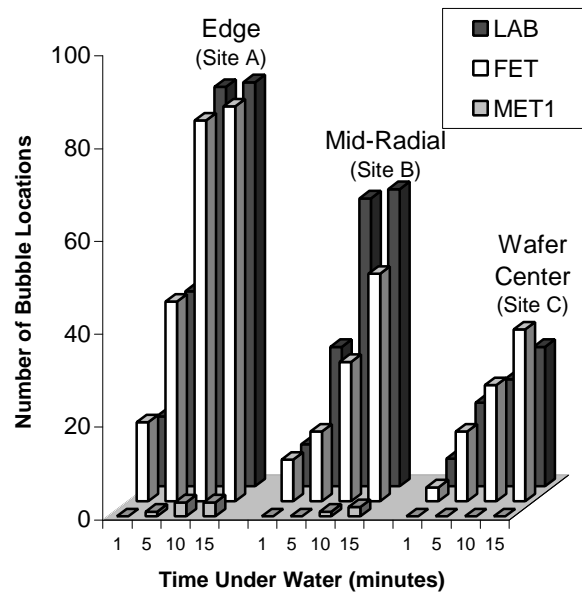
Radial Effect on Hermeticity. Bubble tests on multiple lots have shown that hermeticity is compromised more at the edge of wafers than in the center. The majority of wafers were found to have more bubbling sites near the edges than in the center. Figure 3 shows the radial effect for a group of five random wafers. Figure 3 also shows the relative occurrence of bubbling (with time) from the three structure topologies that are possible breach locations on wafers in this study.

Figure 3. Composite of Bubbling Sites by Location on Wafer (Cumulative for 5 Wafers Before Optimization).

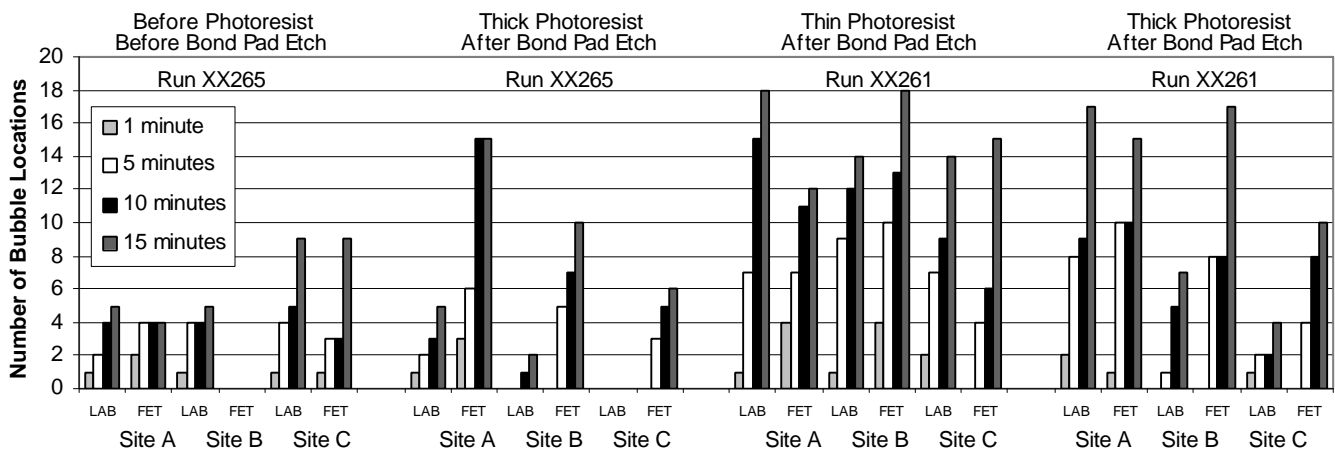
Bond Pad Photoresist. Bubble tests on multiple lots have shown that hermeticity is compromised by the bond pad etch process. Experiments on two lots have shown that a thicker photoresist reduces the damage at the bond pad etch step. This was one of the significant results of this project. It was determined that the original photoresist was not adequate, and hermeticity was degraded during the bond pad etch step. The bond pads are overetched considerably in this particular process because all the nitride layers are removed in the scribe streets during the bond pad etch step.

Figure 4. Loss of Hermeticity Through Bond Pad Etch Process, Comparing Use of Thick and Thin Photoresist.

Using electrolysis testing as an evaluation method for semiconductor hermeticity, this investigation has found three sources of hermeticity loss during processing. 1) Wafers are non-hermetic during early processing steps, but are eventually sealed. 2) Hermeticity is lost between airbridge post etch and final passivation steps. 3) Bond pad etch did cause hermeticity loss before photoresist was thickened.

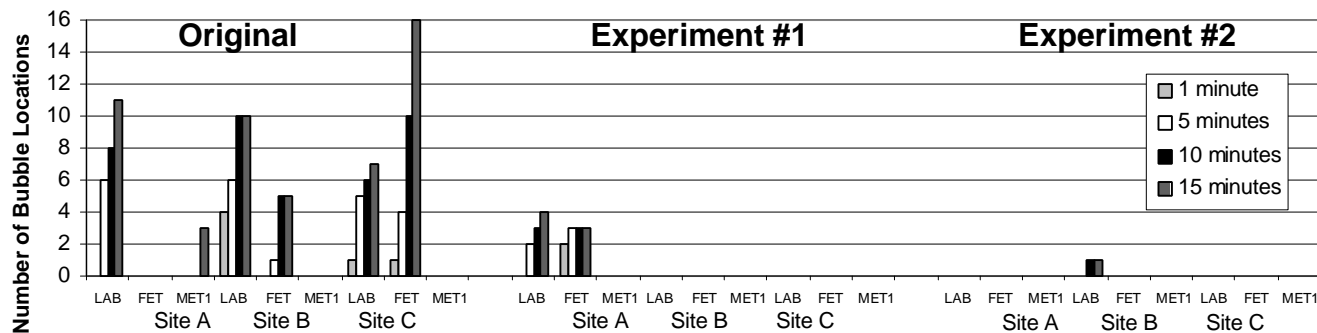
Figure 5. Number of Bubble Sites per Wafer Vs. Improvement Experiment.

The dramatic decrease of bubble sites with Experiment #1 and Experiment #2 are the major breakthroughs of this study. The improvement of both experiments is strongly evident in Figure 5. This experiment was repeated on two additional lots with identical results and the process was updated. Experiment #2 has produced consistently hermetic wafers with one or fewer bubble sites on every lot.

The process enhancements of thicker bond pad photoresist, and use of the process implemented in Experiment #2, results in hermetic die all the way through the fabrication and assembly process – a significant improvement. These hermetic products have subsequently survived 500 hour HVZPM testing in final packaged form.
